**Flood Control Project Maintenance
Levee Inspections**

Fall 2008 Levee Maintenance Deficiency Summary Report

San Joaquin River Basin

Reclamation District No. 2095

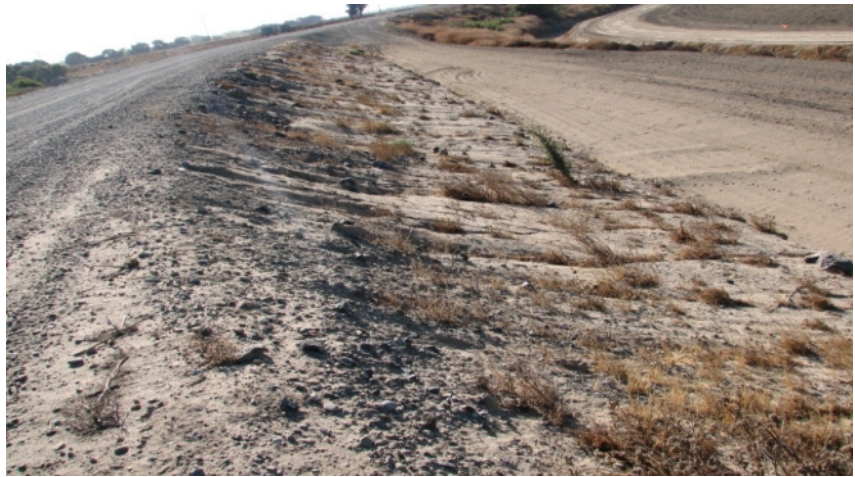
Levee Mile Report Line	1
Start Levee Mile	0.00
End Levee Mile	0.60
Location	
Category	Earthen Levee
Item	Erosion / Bank Caving
RD 2095 unit 1 , LM 0 to 0.6 erosion on the LS requires attention.

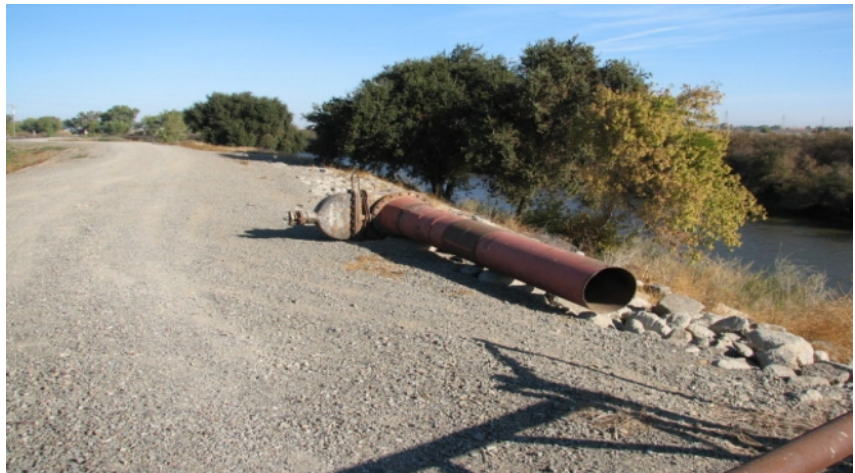
Levee Mile Report Line	4
Start Levee Mile	0.88
End Levee Mile	0.88
Location	
Category	Earthen Levee
Item	Encroachments
LM .88 RD 2095 unit 1 Paradise Cut. Pipe on WS should be removed. Failure to do so may encourage, simply by example, additional equipment to be left on the levee for 'later' removal.

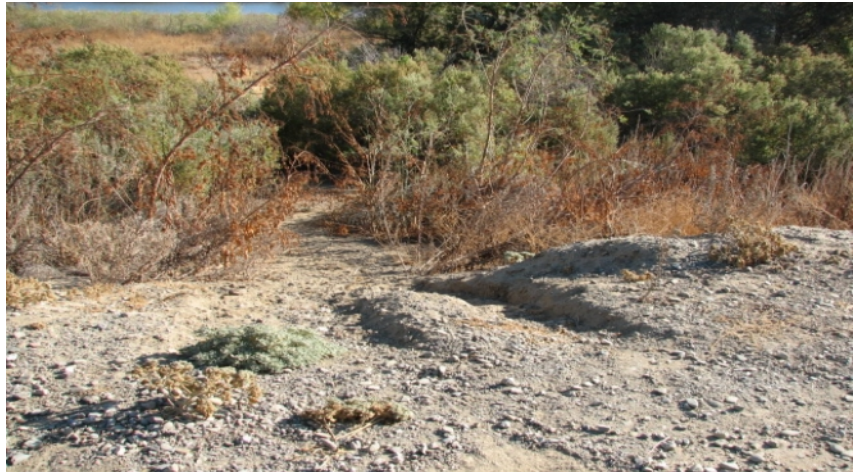
Levee Mile Report Line	4
Start Levee Mile	0.14
End Levee Mile	0.14
Location	
Category	Earthen Levee
Item	Erosion / Bank Caving
RD 2095 unit2. WS bank caving at LM 0.14.

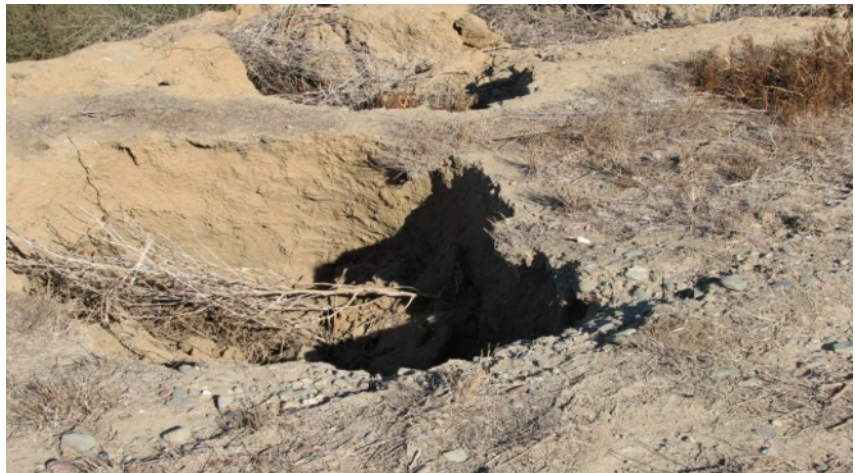
Levee Mile Report Line	16
Start Levee Mile	1.81
End Levee Mile	1.81
Location	
Category	Earthen Levee
Item	Erosion / Bank Caving
RD 2095 unit2. LS caving, quite large. Should be repaired ASAP. Possible threat especially during any flood fight attempt in this area.

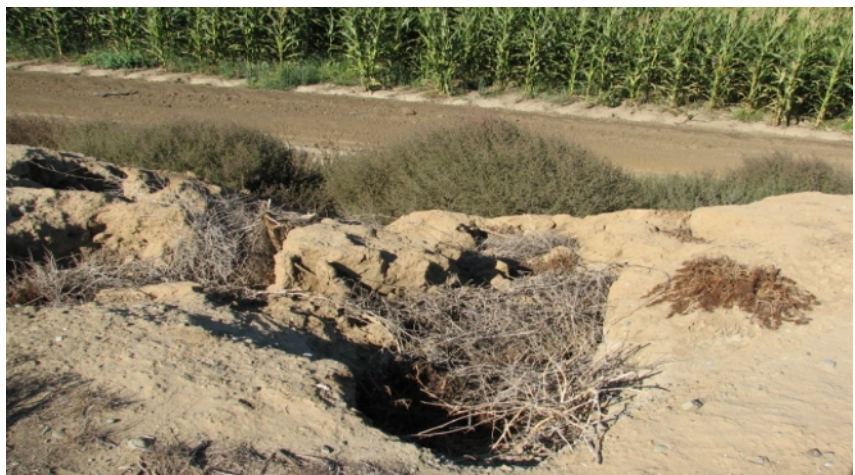
Levee Mile Report Line	16
Start Levee Mile	1.81
End Levee Mile	1.81
Location	
Category	Earthen Levee
Item	Erosion / Bank Caving
Another view.

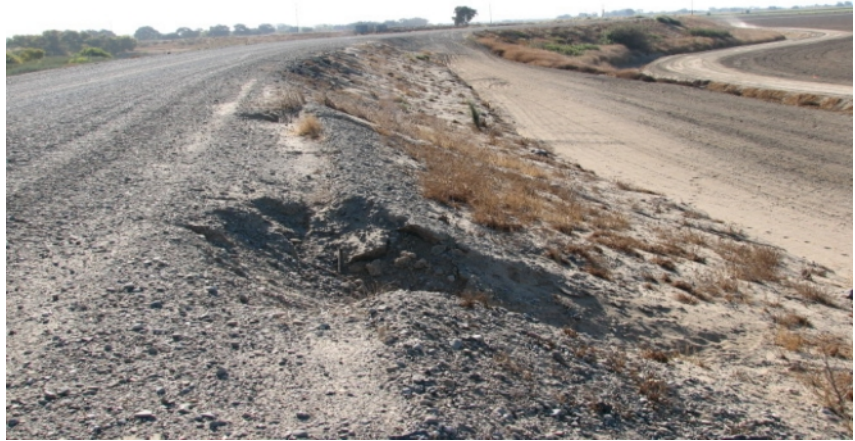
Levee Mile Report Line	21
Start Levee Mile	2.14
End Levee Mile	2.27
Location	
Category	Earthen Levee
Item	Erosion / Bank Caving
Rd 2095 unit 2. LS erosion and bank caving.
